Building & Pest Inspection Reports

135 Albany Forest Drive
Albany Creek

Tuesday, 20 January 2026

Re: Building & Timber Pest Inspection of Residence
135 Albany Forest Drive, Albany Creek

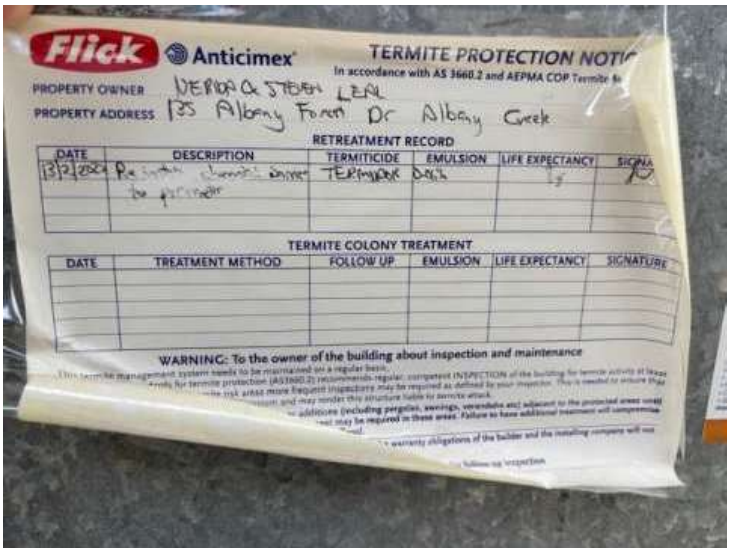
perimeter in 2022. An example of the sticker is shown in the below photo.
