Building & Pest Inspection Reports

70 Oxford Crescent
Bridgeman Downs

Re: Building & Timber Pest Inspection of Residence
70 Oxford Crescent, Bridgeman Downs

BUILDING & TIMBER PEST INSPECTION REPORT TO AS4349.1 2007 & AS4349.3 2010

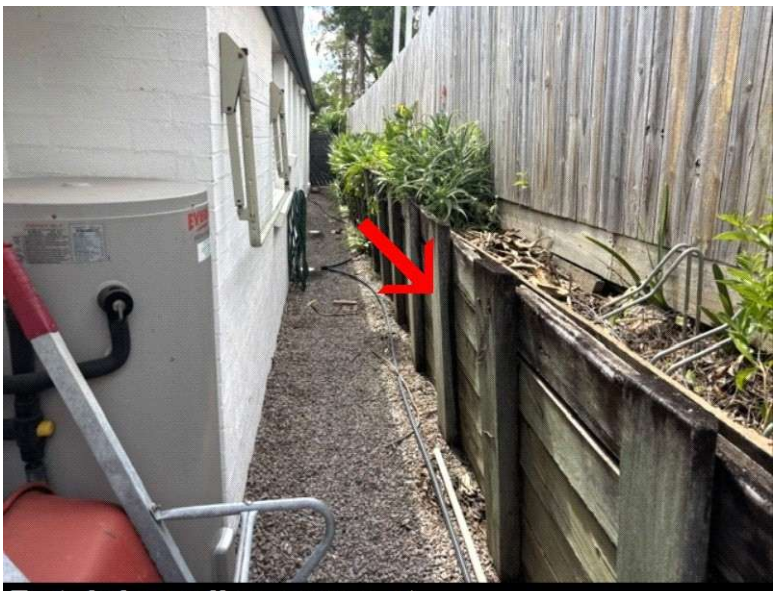
PATHS & DRIVEWAYS

Satisfactory.

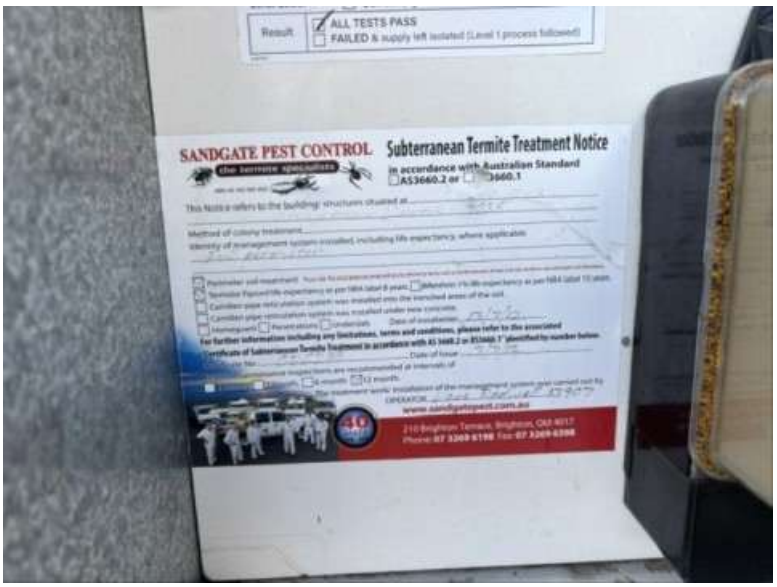
EVIDENCE OF TERMITE TREATMENTS / BARRIERS TO THE PROPERTY

Description:
Yes, there is evidence of a previous termite treatment.
